Your Inspection Report

280 Beech Avenue
Toronto, ON M4E 3J2

INSPECTION DATE:
Tuesday, May 14, 2024

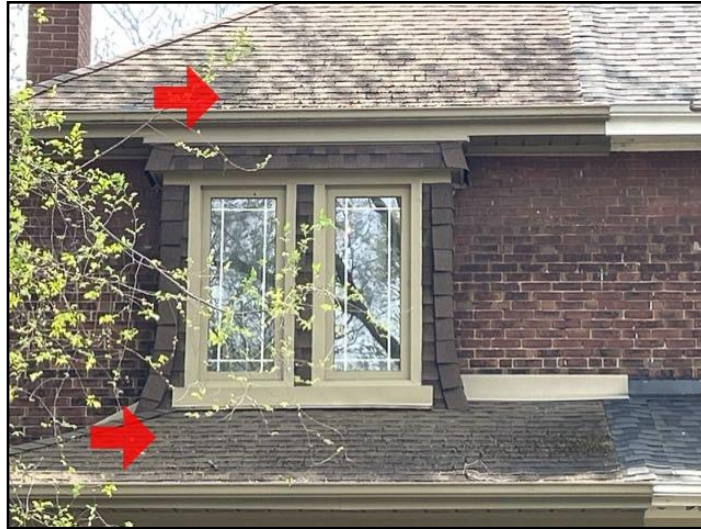
Condition: • Moss - the east facing slope does not get a lot of sun and is therefore slow to dry, allowing for moss to take hold. The shingles overall appear to be in good condition.

Implication(s): Increased wear

Moss

Task: Clean/monitor

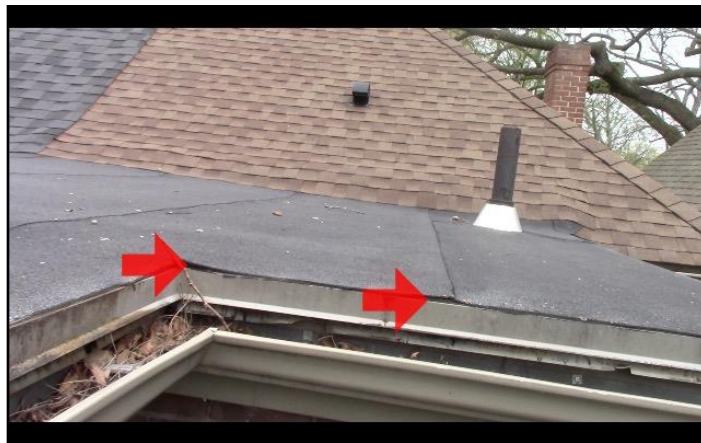
The flat roof material appears to be in good condition, but it needs a tune-up.

Implication(s): Chance of water damage to structure, finishes and contents

Openings at seams or flashings

Task: Repair

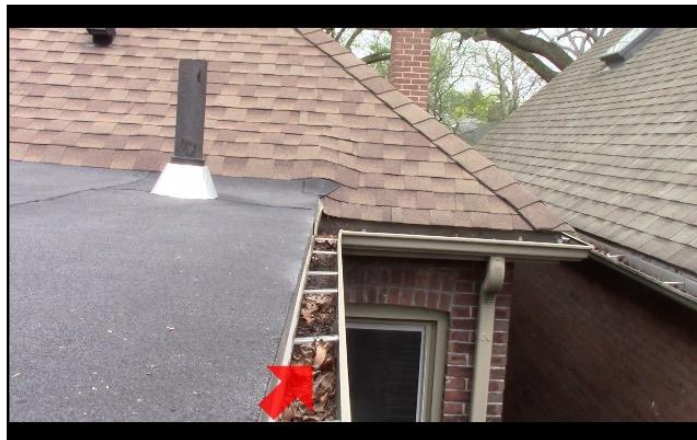
Implication(s): Chance of water damage to structure, finishes and contents

Clogged

Task: Clean

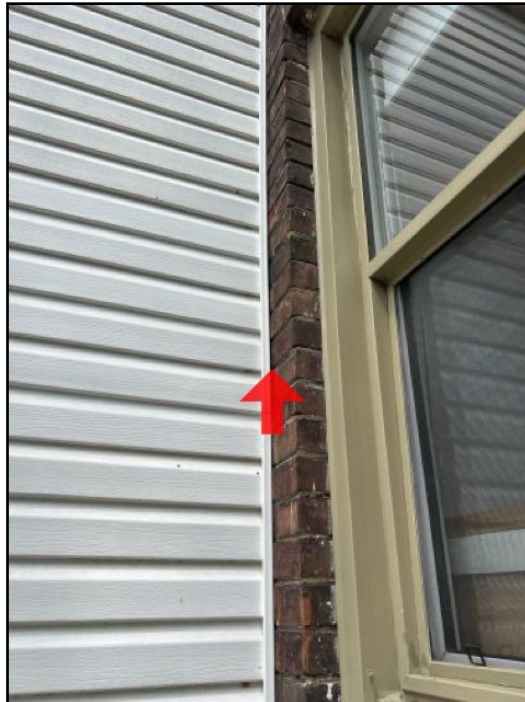
Implication(s): Chance of water damage to structure, finishes and contents

Caulking missing or ineffective

Task: Provide

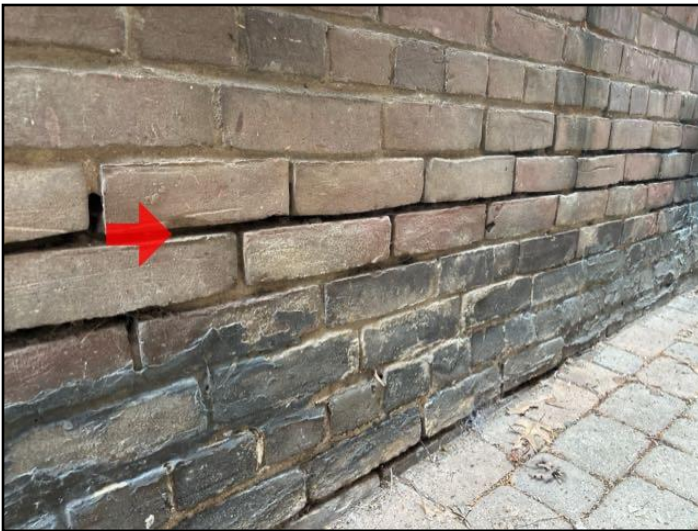
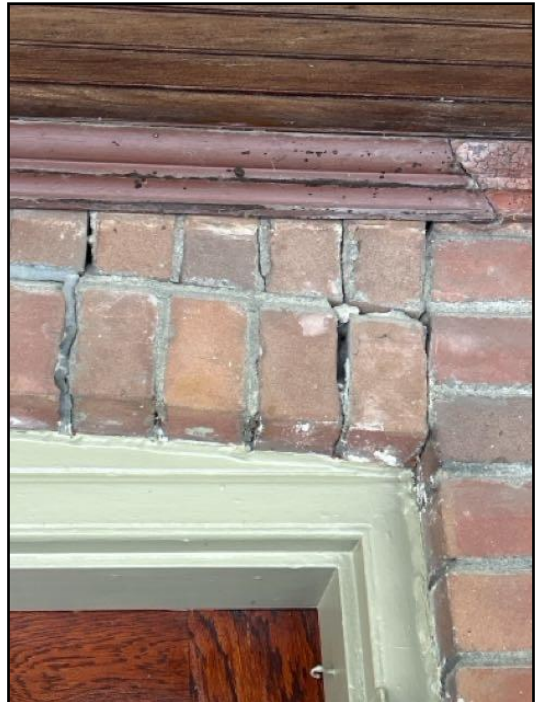
Implication(s): Chance of water entering building | Weakened structure | Chance of structural movement

Mortar deterioration

Task: Repair

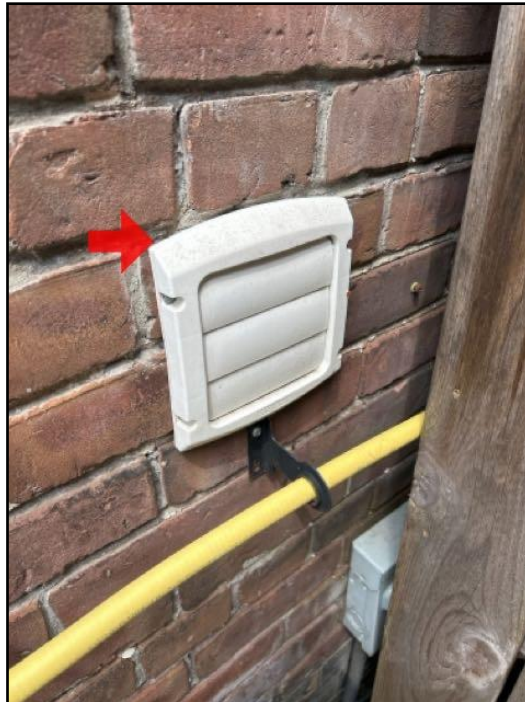
Condition: • Caulking deteriorated/missing

Caulking deteriorated/missing

Task: Provide

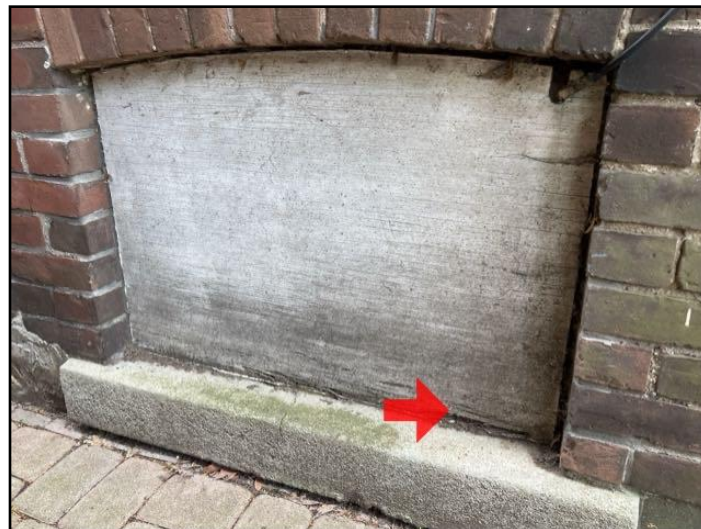
Condition: • Rot at abandoned window

Rot

Task: Repair

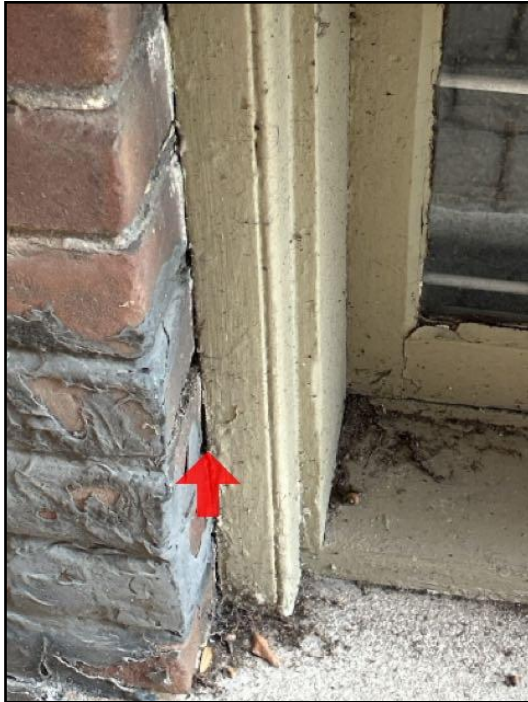
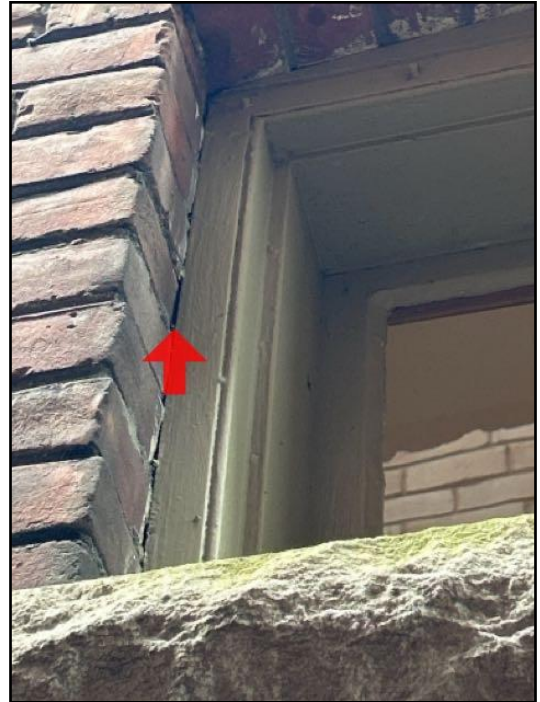
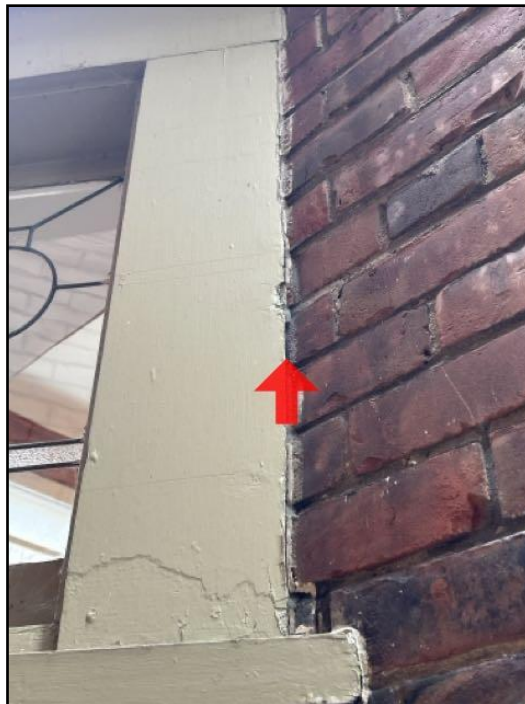
Implication(s): Chance of water damage to structure, finishes and contents

Caulking missing, loose or deteriorated

Task: Provide

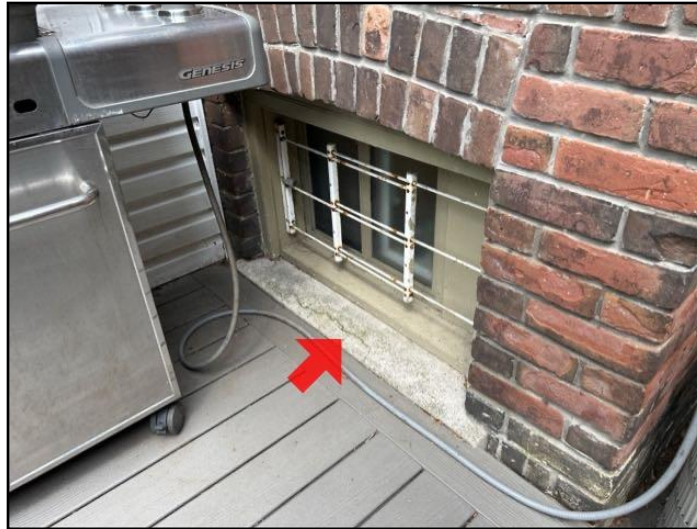
Implication(s): Risk of water infiltration

Windows at grade

Task: Keep window area cleared of snow in winter

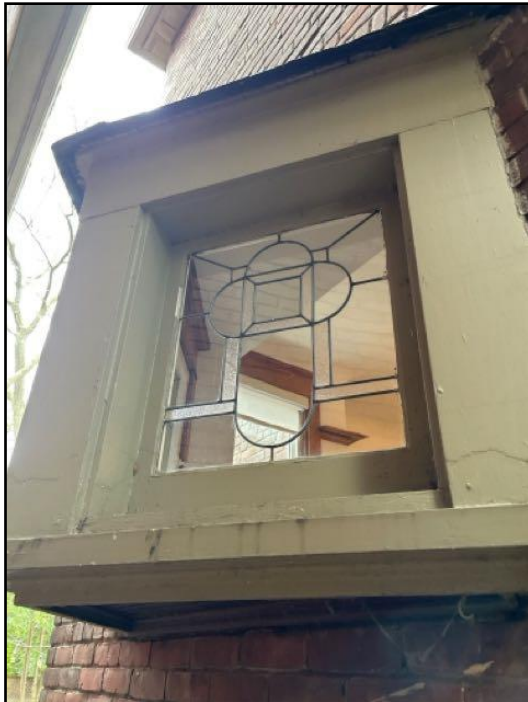
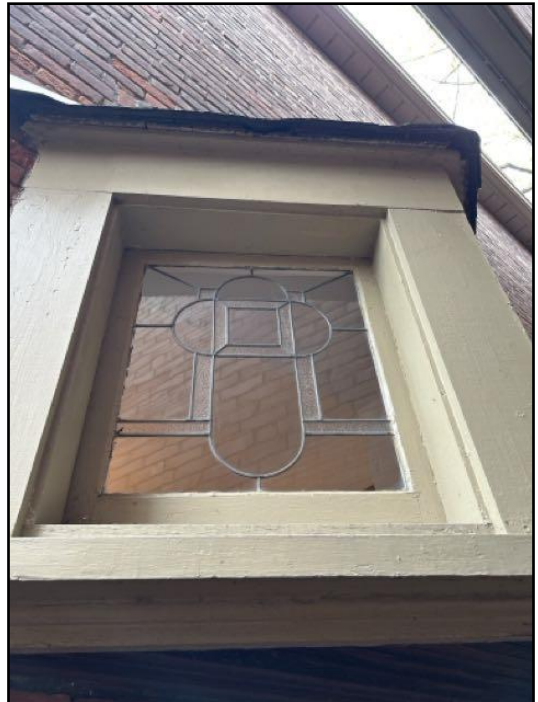
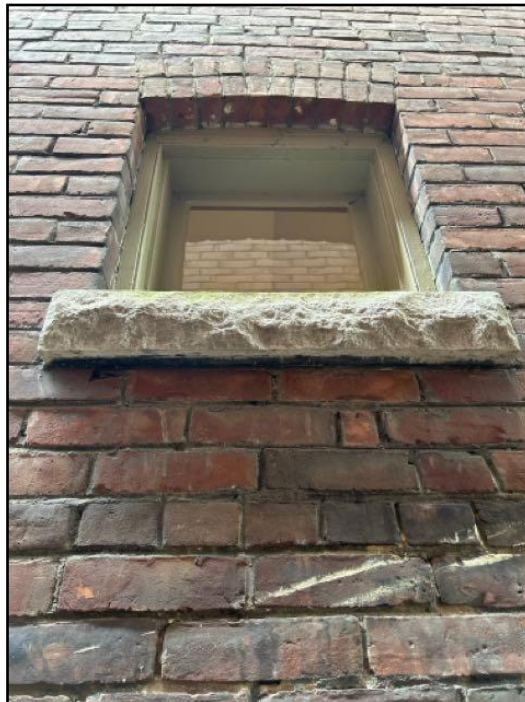
Implication(s): Increased heating and cooling costs | Reduced comfort

Missing storm

Task: Provide

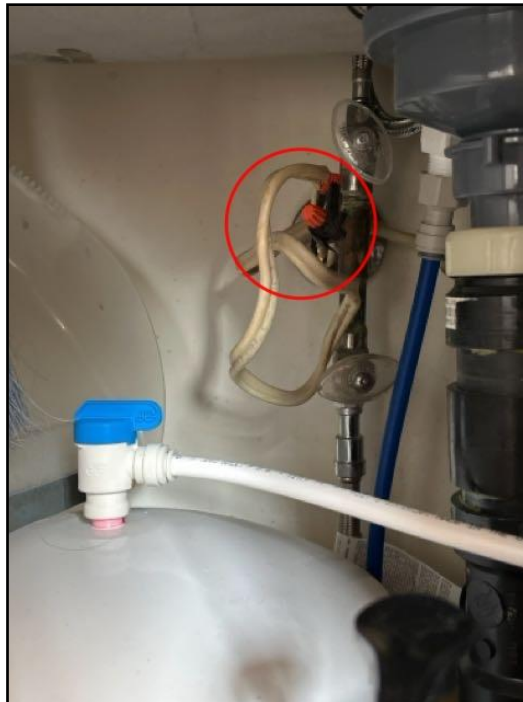
The abandoned wire does not appear to be live.

Implication(s): Electric shock

Abandoned wire

Task: Improve

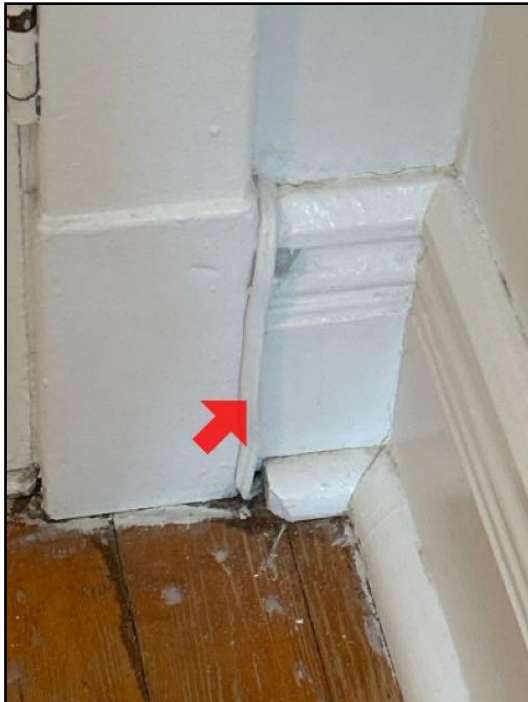
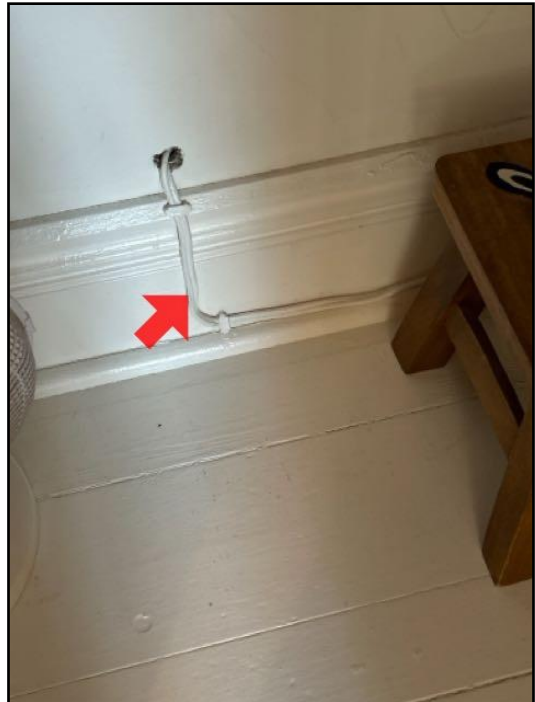
Implication(s): Electric shock

Exposed on walls or ceilings

Task: Improve

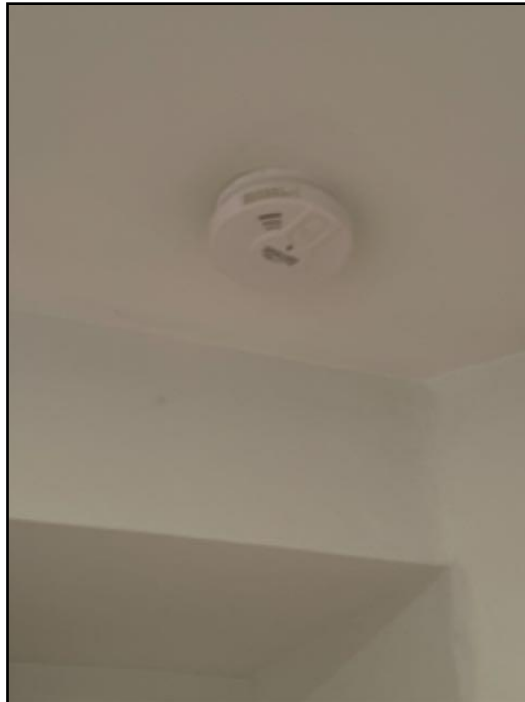
Condition: • Old

Implication(s): Life safety hazard

Old

Task: Replace

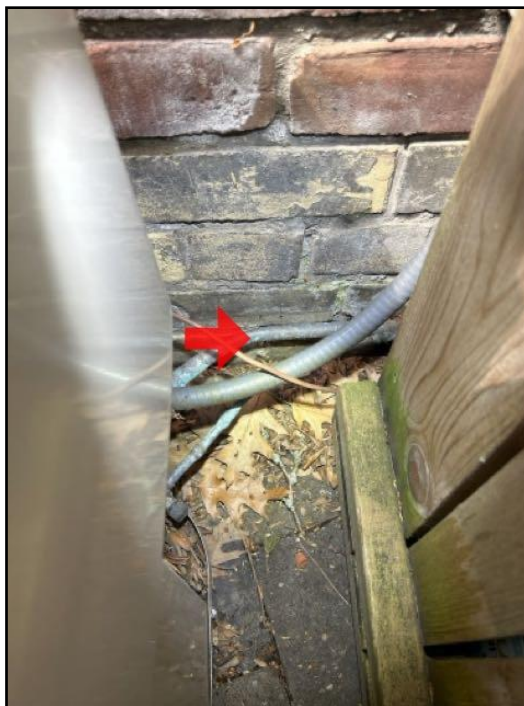
Condition: • Insulation damaged/missing

Insulation damaged/missing

Task: Repair

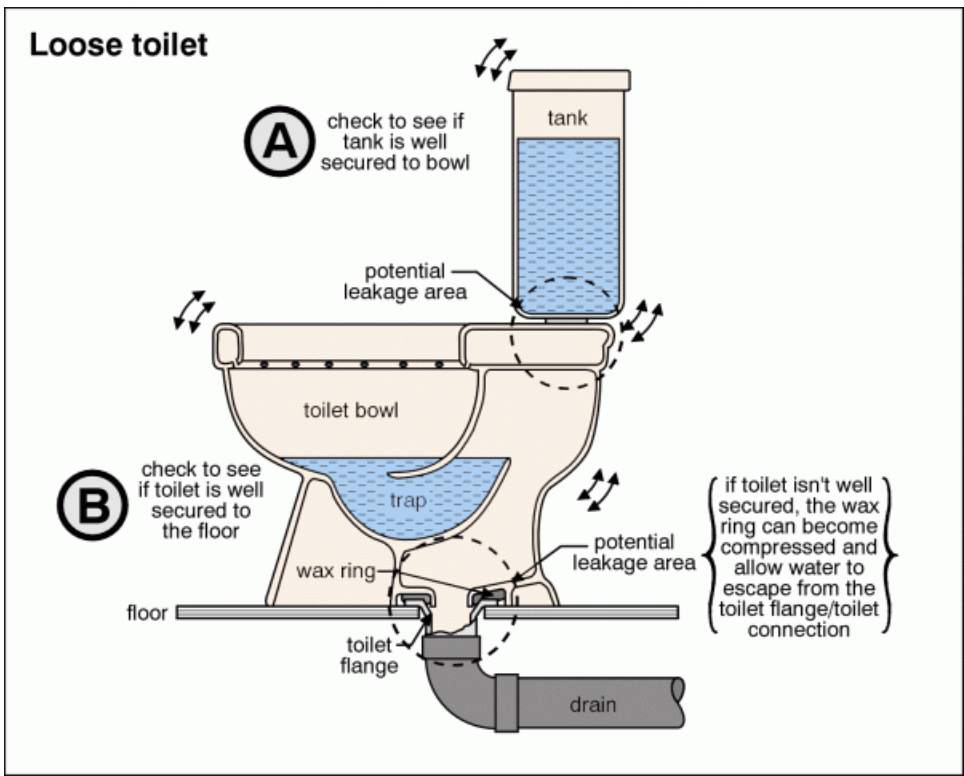
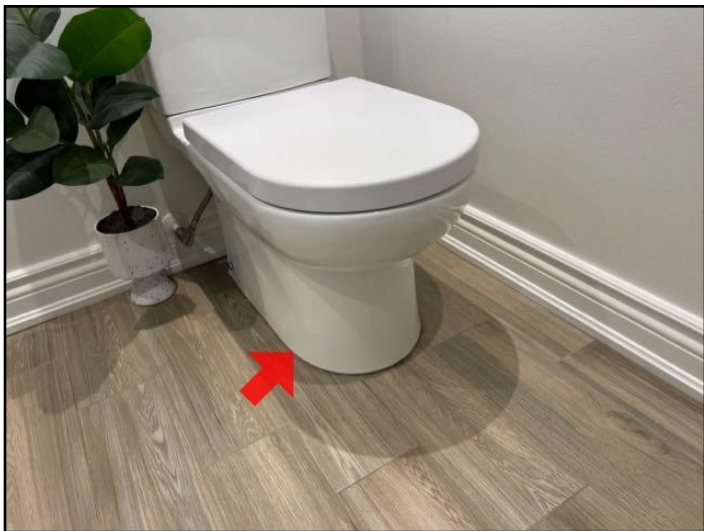
Condition: • [Loose](#)

Implication(s): Chance of water damage to structure, finishes and contents | Sewage entering the building | Possible hidden damage

Loose

Task: Repair

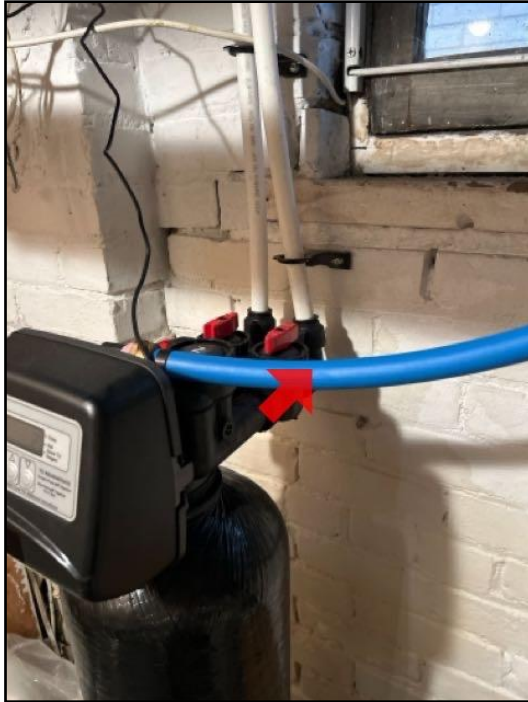
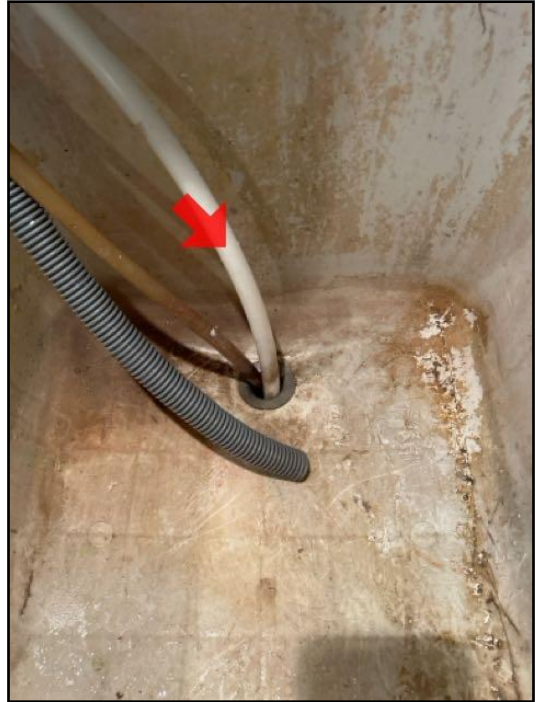
Condition: • Water filter constantly draining water through relief line (terminates in laundry sink)

Implication(s): Increased water usage costs

Water filter relief line

Task: Service

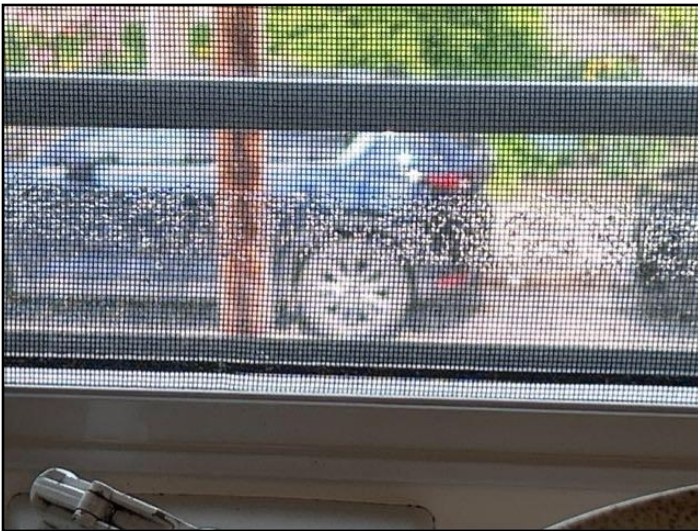
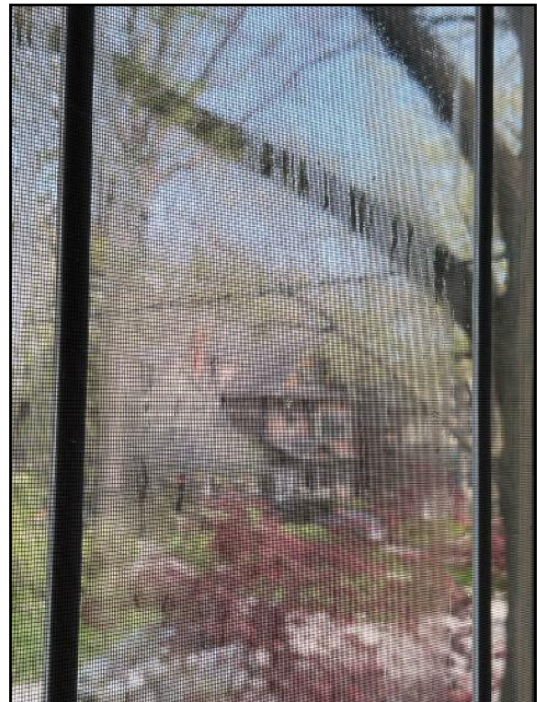
Implication(s): Shortened life expectancy of material

Lost seal on double or triple glazing

Task: Repair or replace
